RESERVE STUDY UPDATE

Park Place Community Development District

Tampa, Florida
April 16, 2019

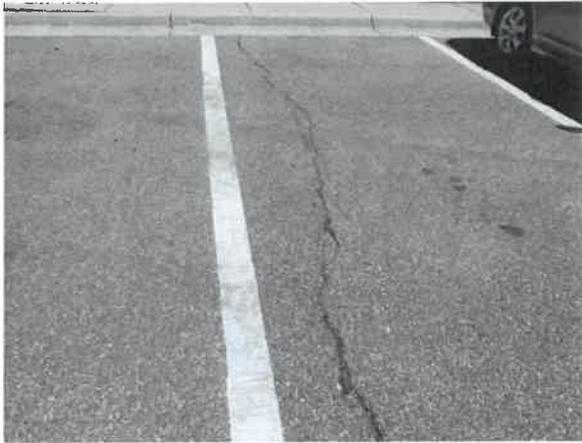
Condition: Good to fair overall with cracks evident

Cracks evident

The manner of repaving is either a mill and overlay or total replacement. A mill and overlay is a method of repaving where cracked, worn and failed pavement is mechanically removed or milled until sound pavement is found. A new layer of asphalt is overlaid atop the remaining base course of pavement. Total replacement includes the removal of all existing asphalt down to the base course of aggregate and native soil followed by the application of two or more new lifts of asphalt. We recommend mill and overlay on asphalt pavement that exhibits normal deterioration and wear. We recommend total replacement of asphalt pavement that exhibits severe deterioration, inadequate drainage, pavement that has been overlaid multiple times in the past or where the configuration makes overlayment not possible. Based on the apparent visual condition and configuration of the asphalt pavement, we recommend the mill and overlay method of pavement at Park Place.

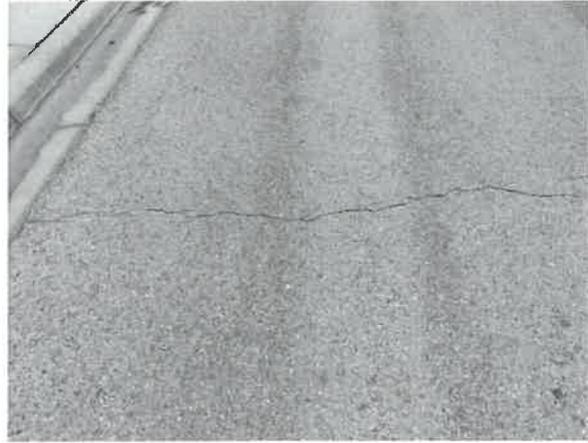
Cracks evident

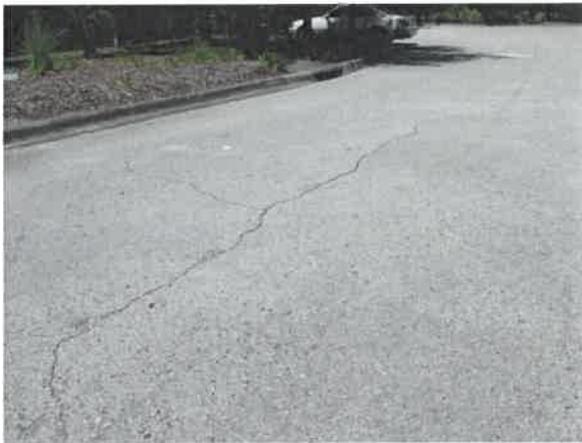
Cracks evident

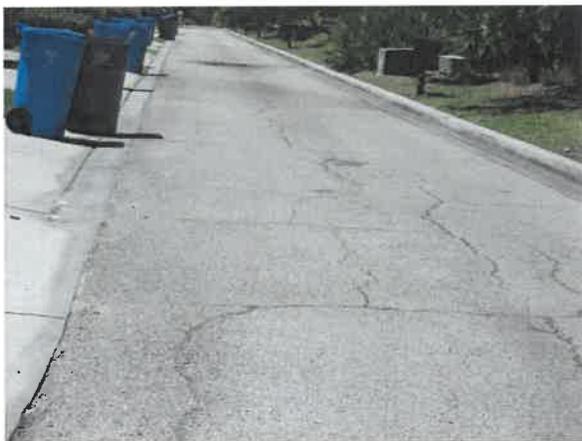
Cracks evident

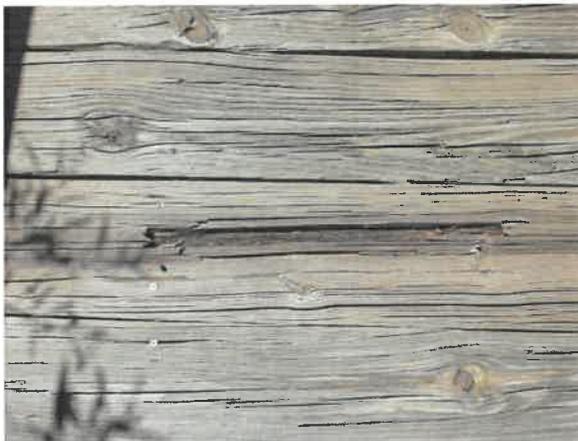
Condition: Fair overall with wood deterioration evident

Wood deterioration evident

- Inspections to identify and correct any unsafe conditions
- Securing of loose fasteners and replacement of deteriorated fasteners
- Replacement of deteriorated wood components
- Power washing with an algaecide and application of a sealer/stain

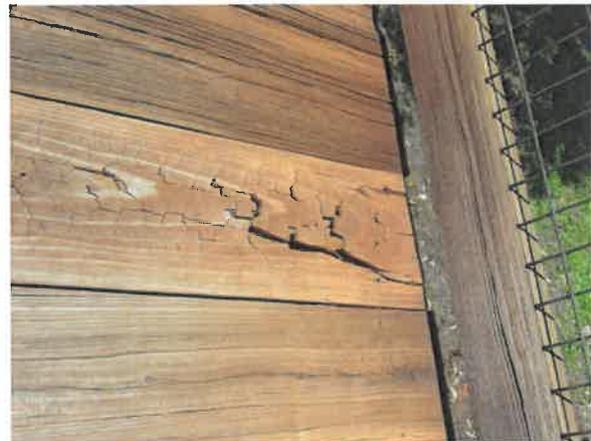
Wood deterioration evident

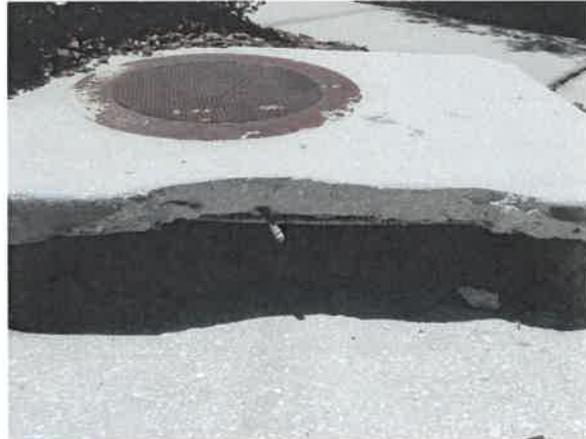
Damage evident with exposed rebar

Component Detail Notes: Erosion causes settlement around the collar of catch basins. Left unrepaired, the entire catch basin will shift and need replacement.

Expenditure Detail Notes: Expenditure timing and costs are depicted in the **Reserve Expenditures** table in Section 3. We recommend the District plan for inspections and capital repairs to the catch basins in conjunction with repaving.

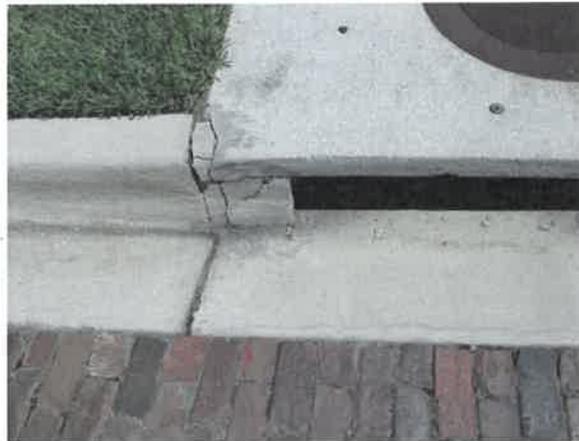
Cracks evident

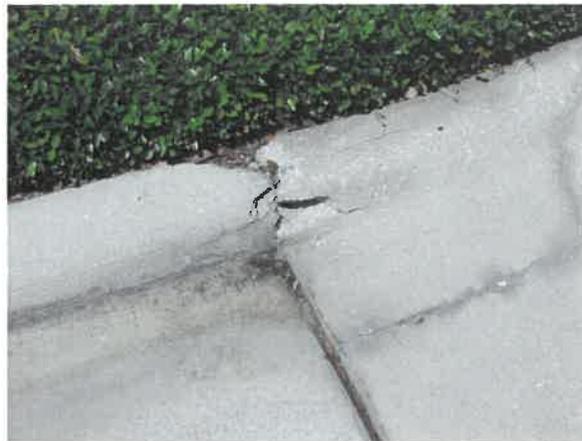
Damage evident

Expenditure Detail Notes: Expenditure timing and costs are depicted in the **Reserve Expenditures** table in Section 3. We estimate that up to 9,180 linear feet of curbs and gutters, or twenty percent (20%) of the total, will require replacement during the next 30 years.

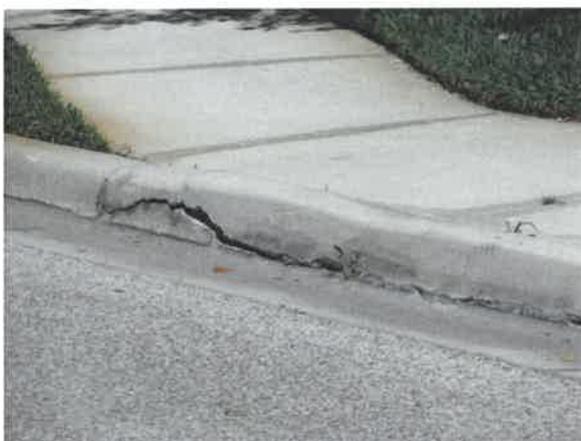
Damage evident

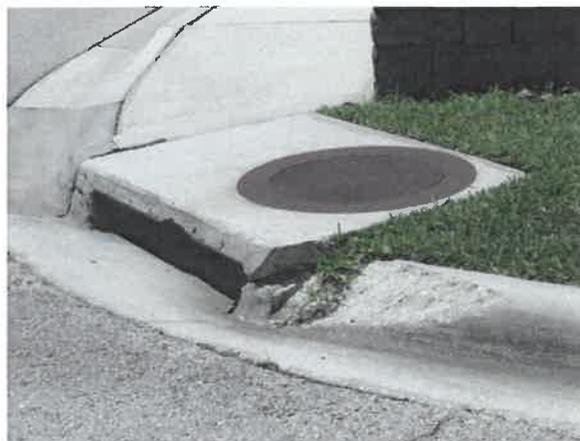
Damage evident

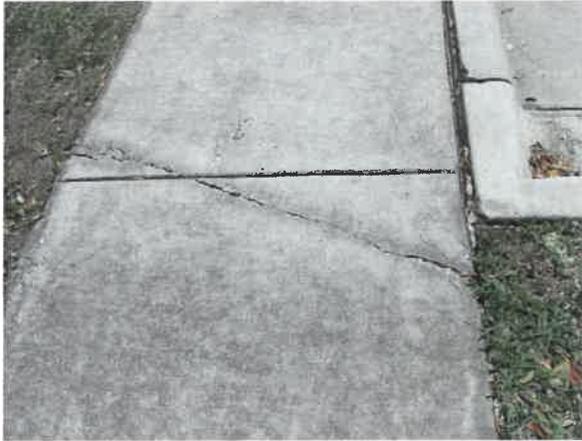
Cracks evident

Expenditure Detail Notes: Expenditure timing and costs are depicted in the *Reserve Expenditures* table in Section 3. We estimate that up to 13,110 square feet of concrete sidewalks, or twenty percent (20%) of the total, will require replacement during the next 30 years.

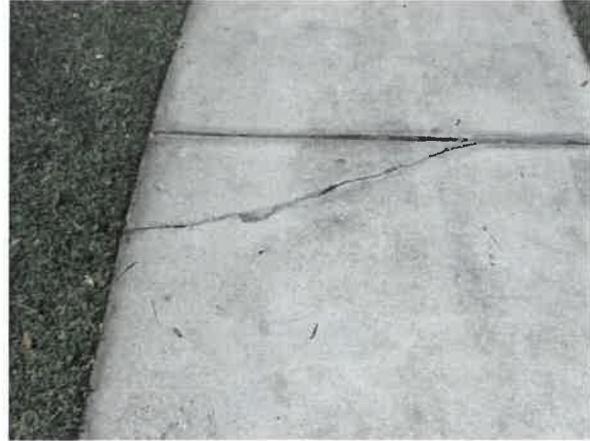
Cracks evident

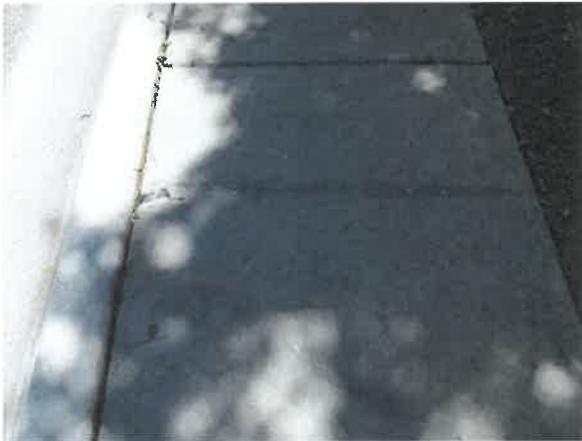
Cracks evident

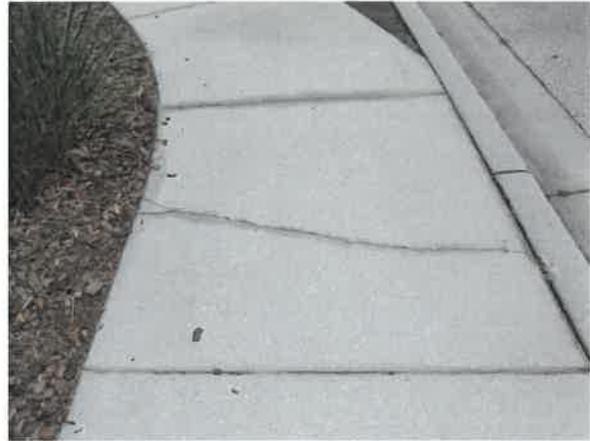
Cracks evident

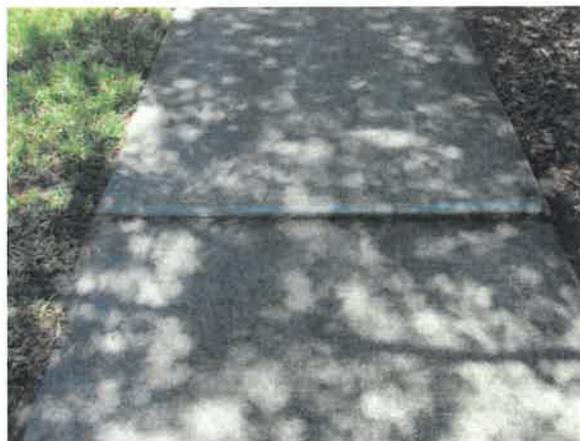
Trip hazard evident

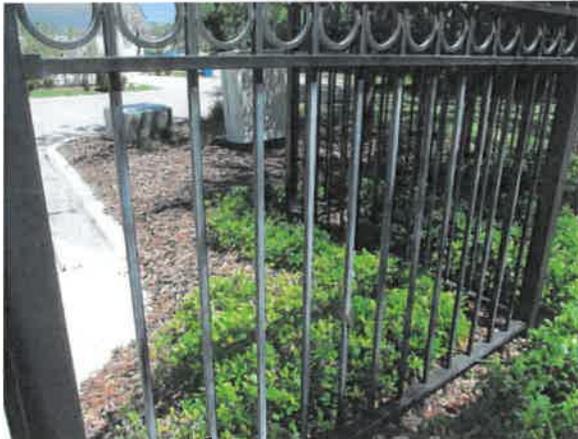
Condition: The fence is in good overall condition and the protective finishes are in fair overall condition with deterioration evident.

Deteriorating finishes evident

Component Detail Notes: Steel components at grade and key structural connections are especially prone to failure if not thoroughly maintained. Secure and rust free fasteners and connections will prevent premature deterioration. Preparation of the steel before application of the paint finish is critical to maximize the useful life of the finish.

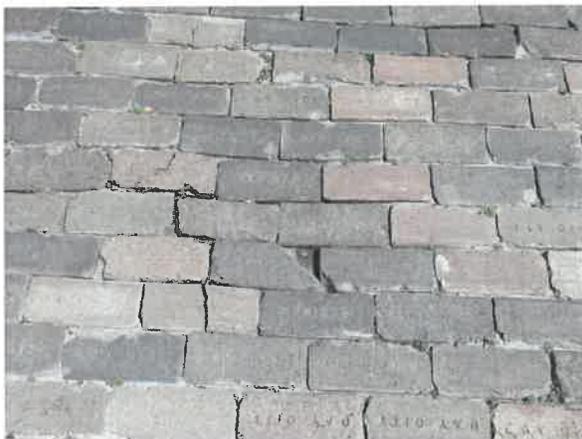
Condition: Good to fair overall with damaged pavers evident

Damage evident

replacement of up to thirty percent (30%). We suggest the District conduct interim resetting and replacement of minor areas of pavers as normal maintenance, funded from the operating budget.

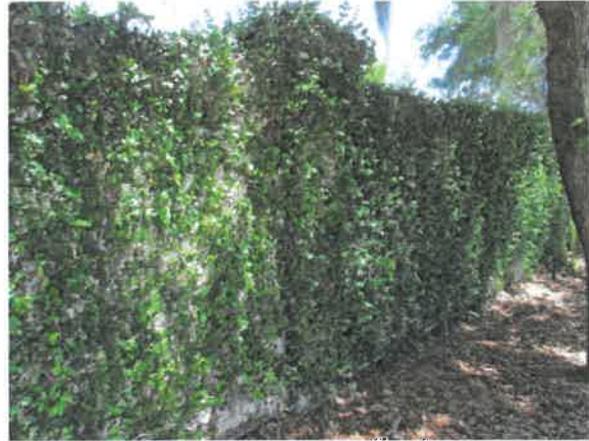
Condition: Good to fair with extensive vegetation evident

Vegetation growth

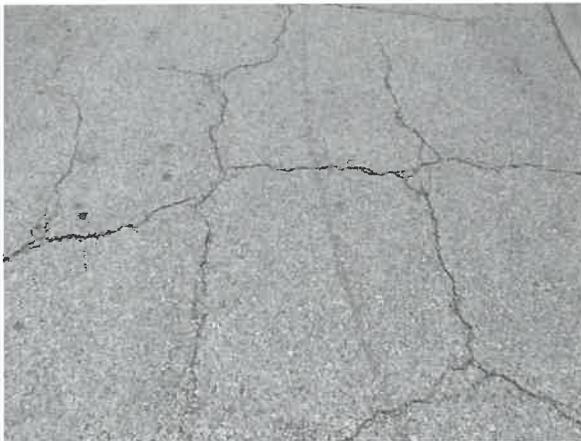
Condition: Fair overall with cracks and block cracks evident

Block cracks evident

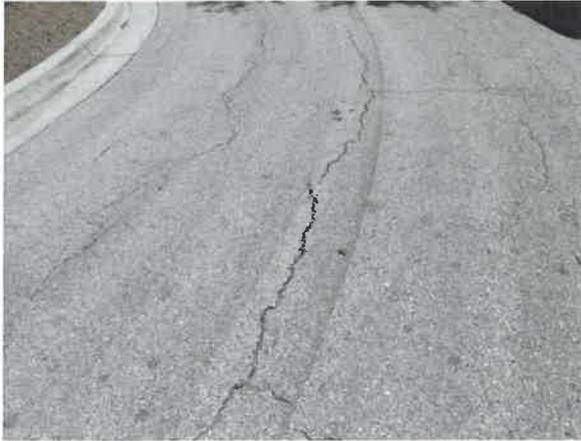
Cracks evident

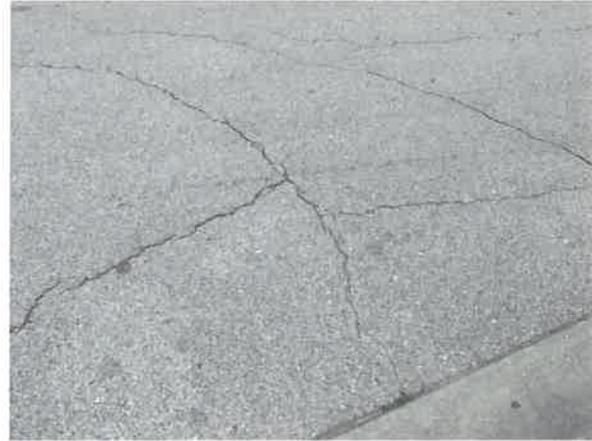
Cracks evident

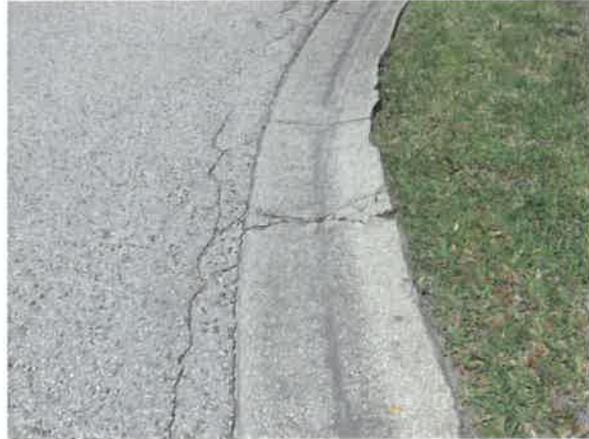
Cracks evident

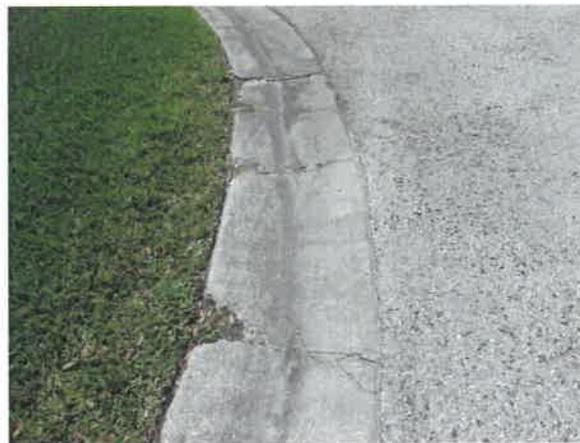
Damage and cracks evident
