RESERVE STUDY UPDATE

Park Place Community Development District

Tampa, Florida
April 16, 2019

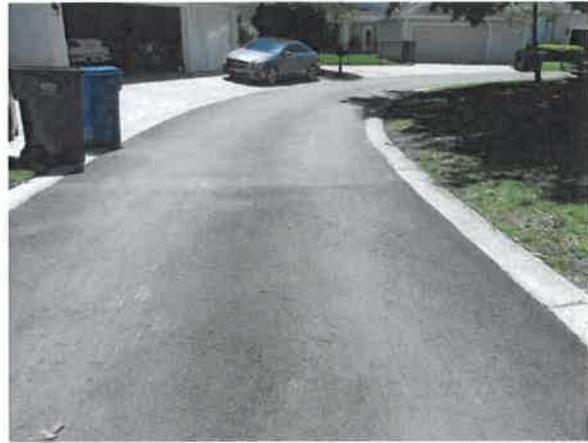
Repaved alleyway

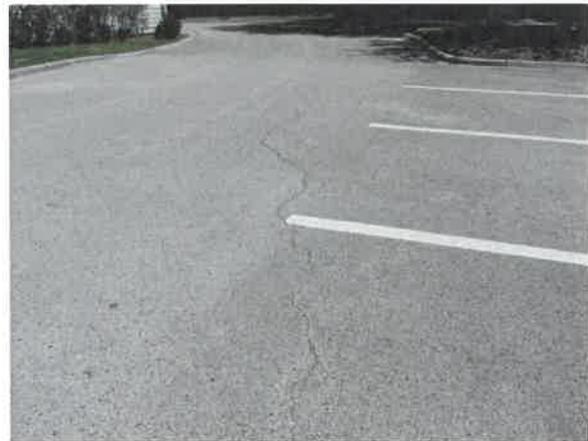
Condition: Good to fair overall with cracks evident

Parking area

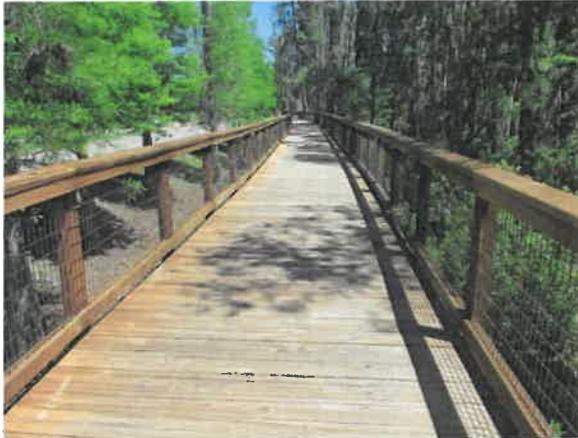
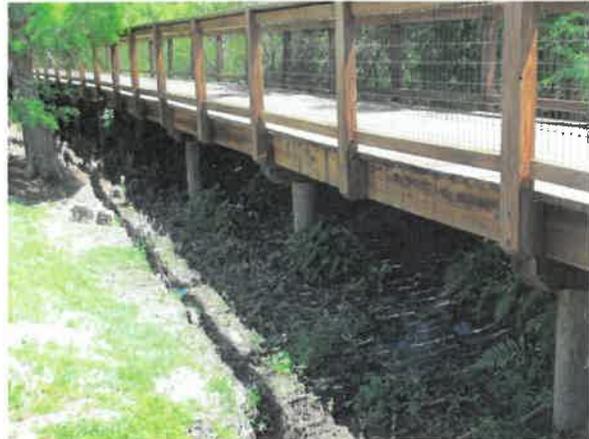
Condition: Fair overall with wood deterioration evident

Boardwalk

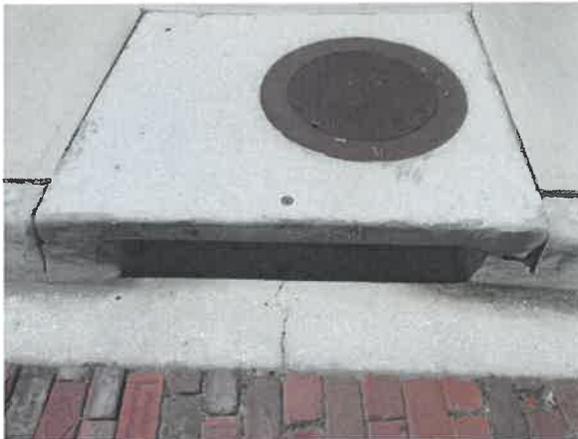
Condition: Good to fair overall with damage evident

Catch basin

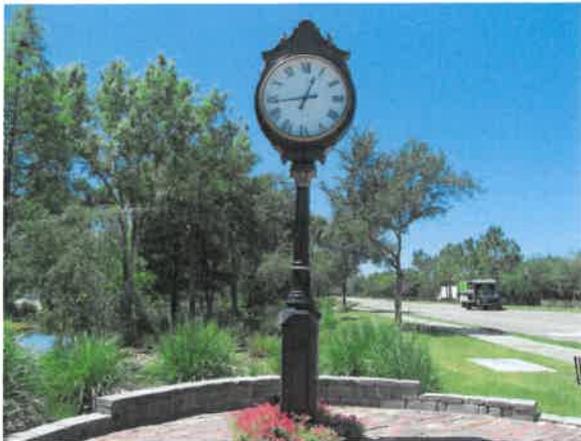
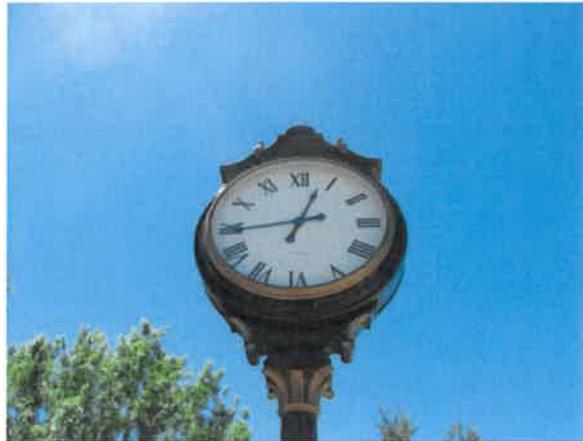
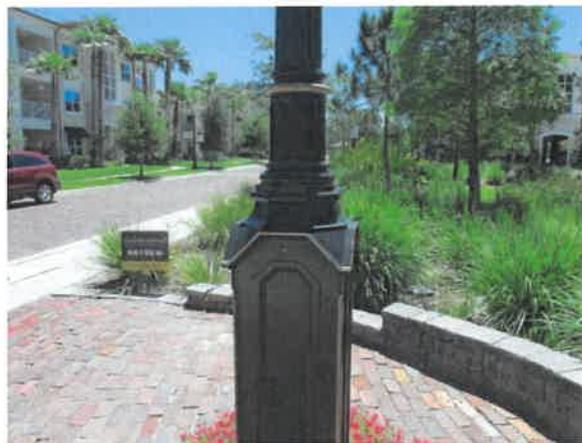
Condition: Good condition

Clock tower

Clock

Clock base

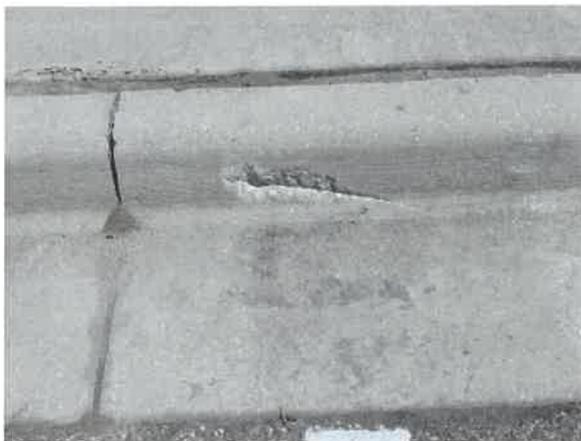
Condition: Good to fair overall with damage evident

Concrete curb and gutter

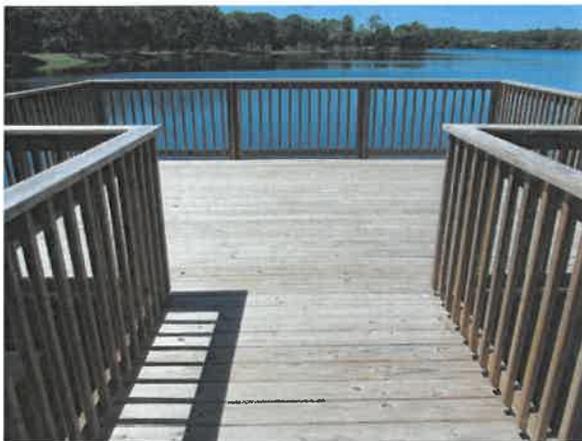
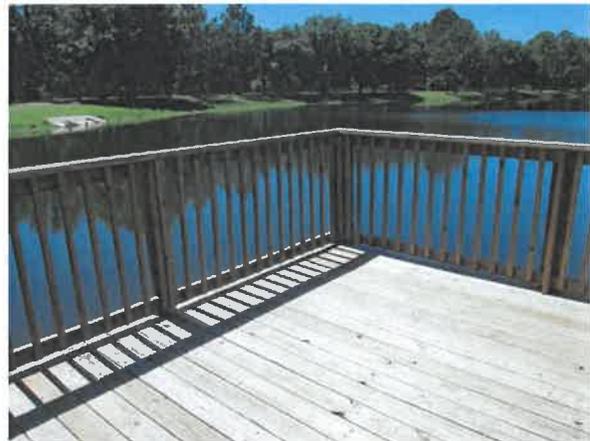
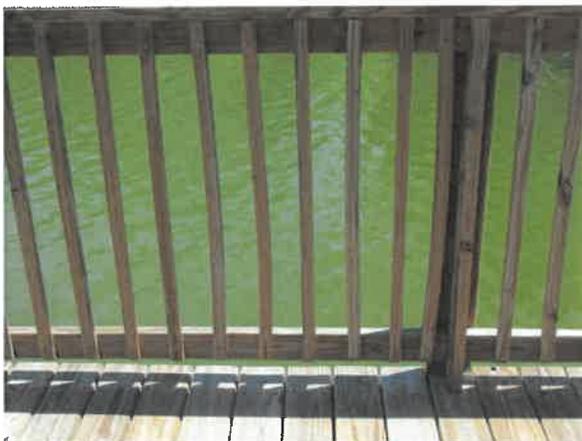
History: Deck boards and railings replaced in 2018

Condition: Good condition

Dock overview

Dock and railings

Wood railings

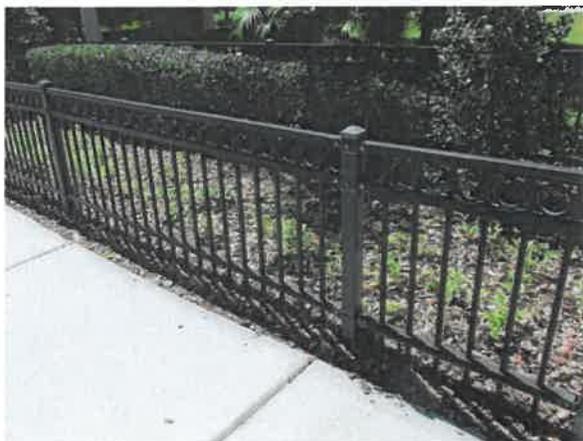
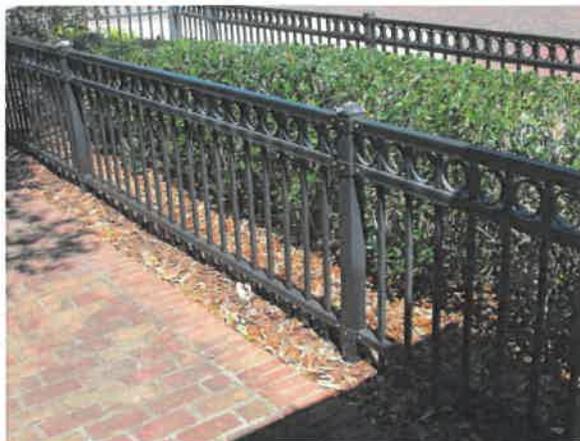
Condition: Good overall with no visible deterioration evident

Fences

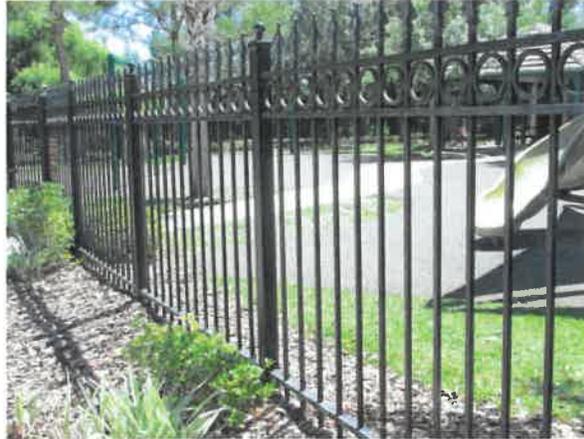
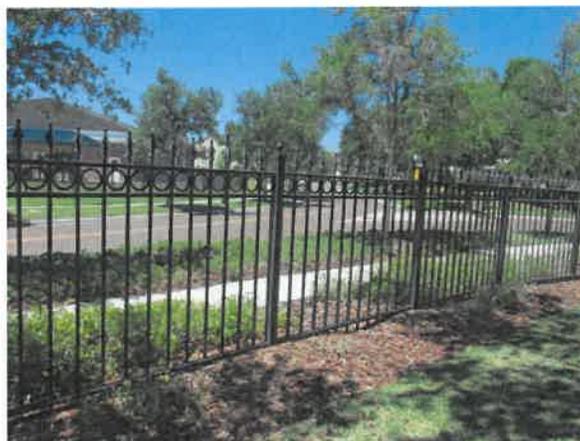
Playground fence

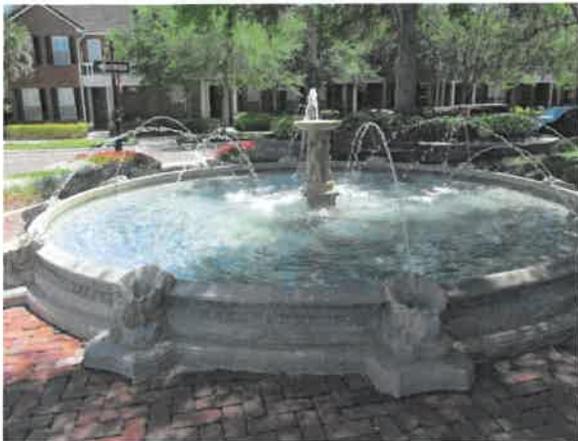
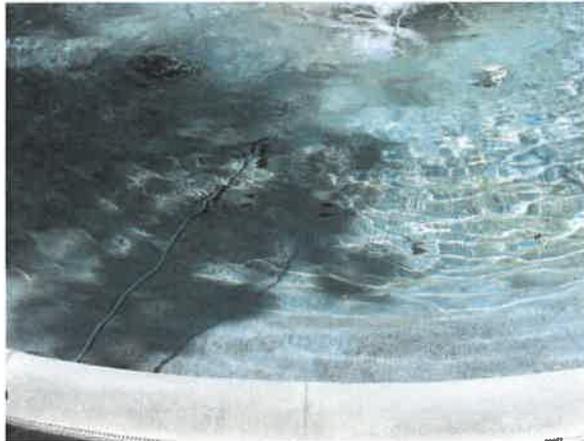
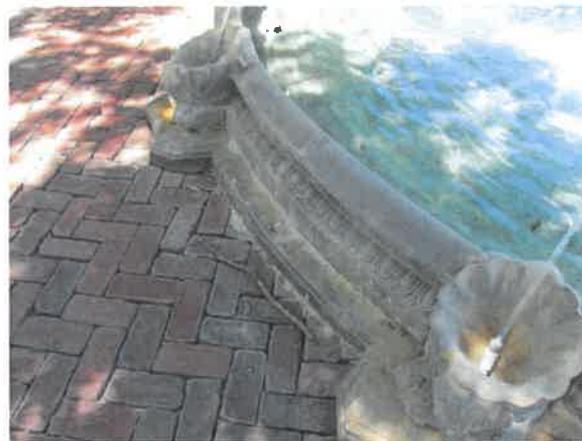
Condition: Good overall

Fountain

Plaster finish

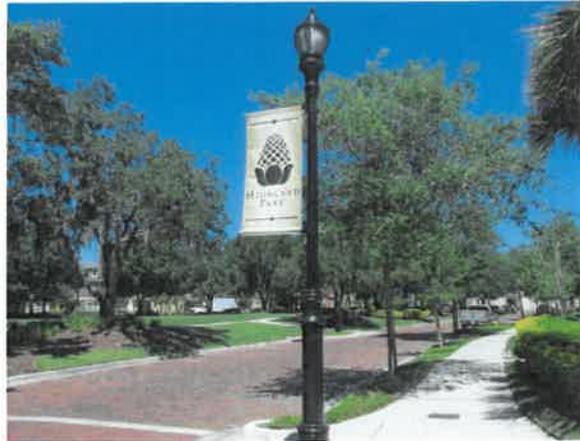
Condition: Good overall

Light pole and fixture

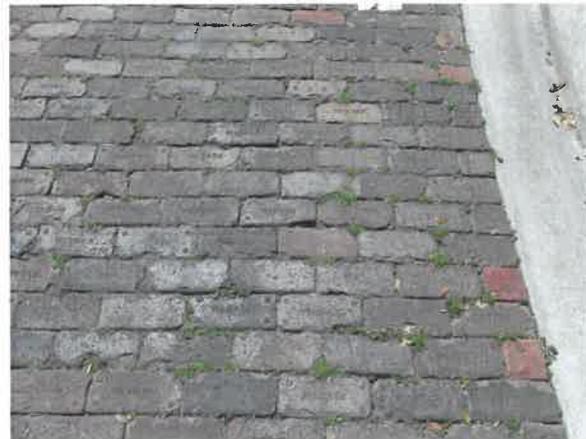
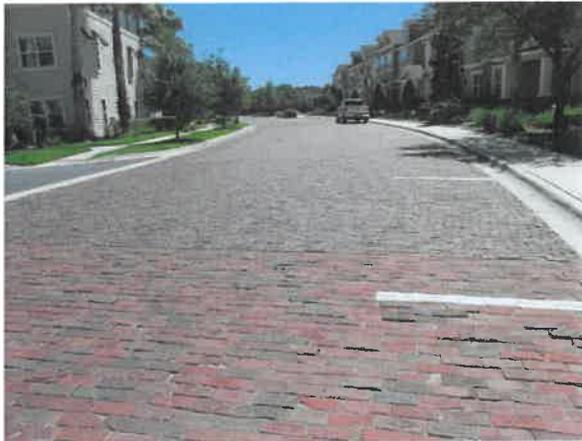
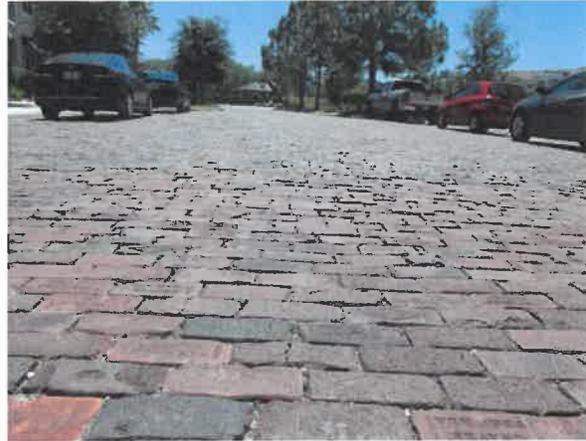
Masonry pavers

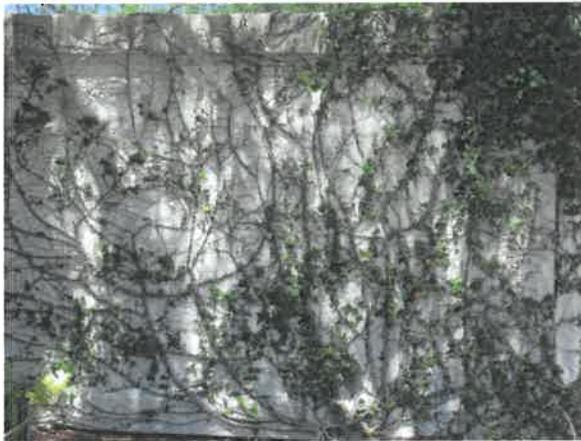
Condition: Good to fair with extensive vegetation evident

Precast concrete wall

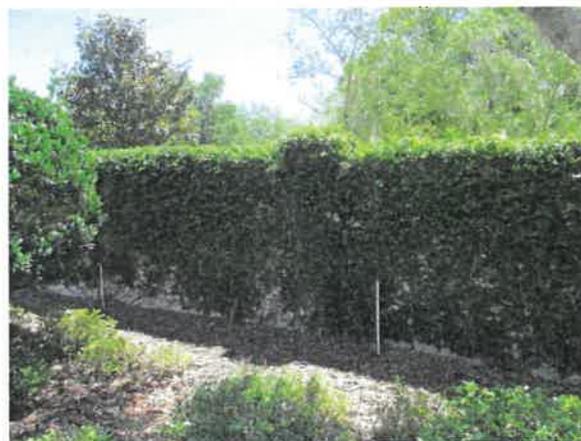
Vegetation growth

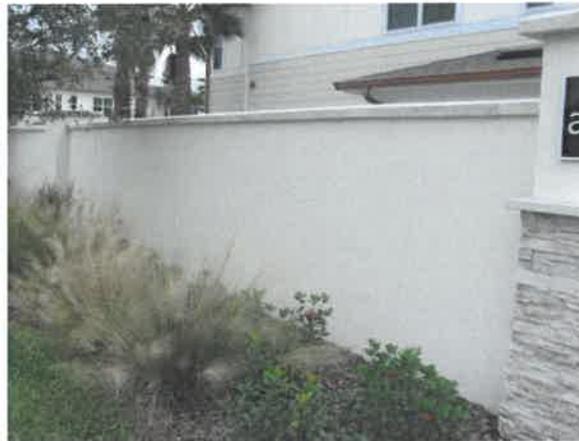
Condition: The walls are in good condition overall and paint finish is in good condition overall with no visible deterioration evident.

Stucco wall

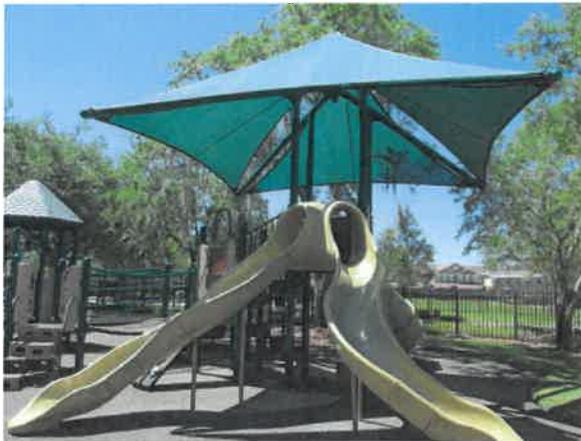
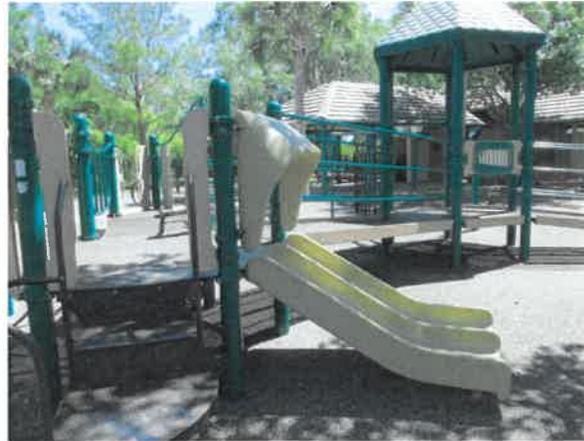
Condition: Good overall

Playground equipment

Component Detail Notes: Safety is the major purpose for maintaining playground equipment. We recommend an annual inspection of the playground equipment to identify and repair as normal maintenance loose connections and fasteners or damaged elements. We suggest the District learn more about the specific requirements of playground equipment at PlaygroundSafety.org. We recommend the use of a specialist for the design or replacement of the playground equipment environment.

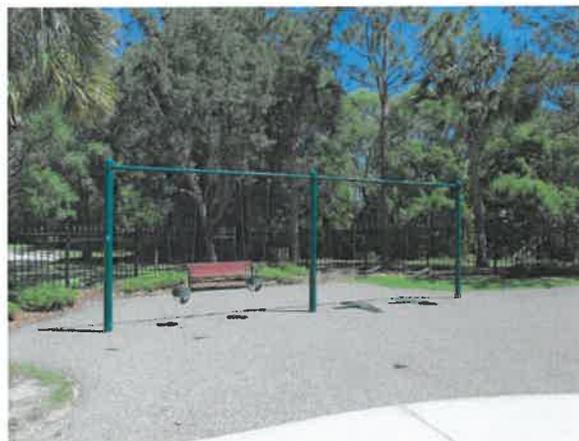
Swing set

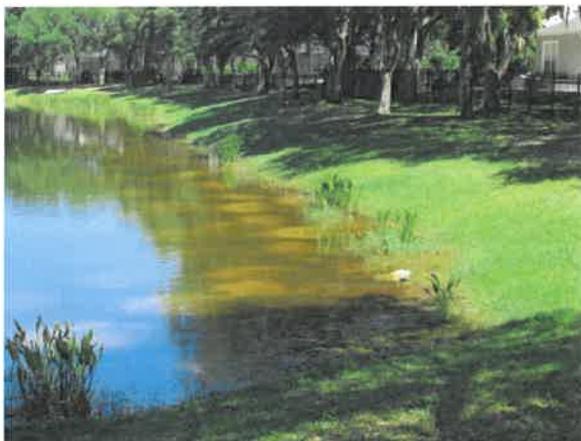
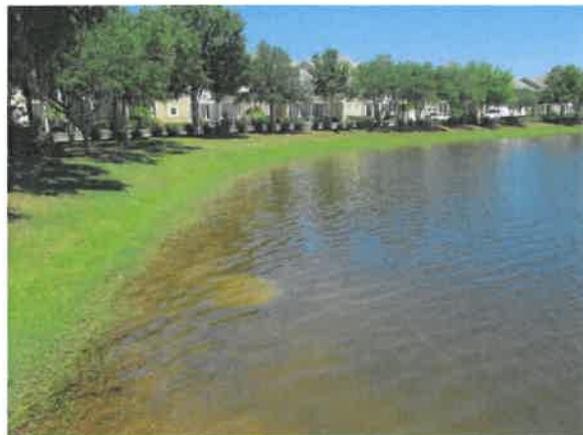
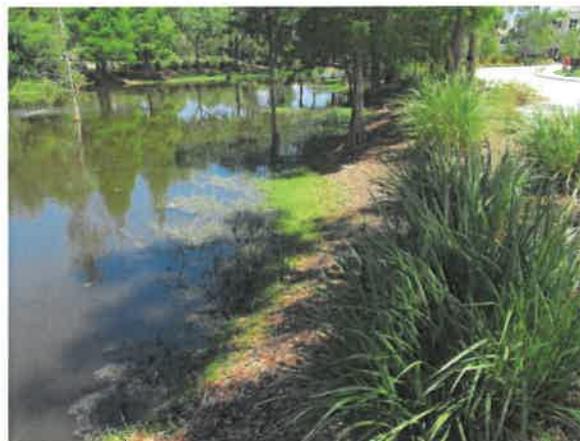
Condition: Good condition overall

Pond shorelines

Expenditure Detail Notes: Expenditure timing and costs are depicted in the **Reserve Expenditures** table in Section 3. We recommend the District plan to install a combination of plantings and rip rap around the pond along 3,045 linear feet, or approximately fifteen percent (15%), of the shoreline per event.

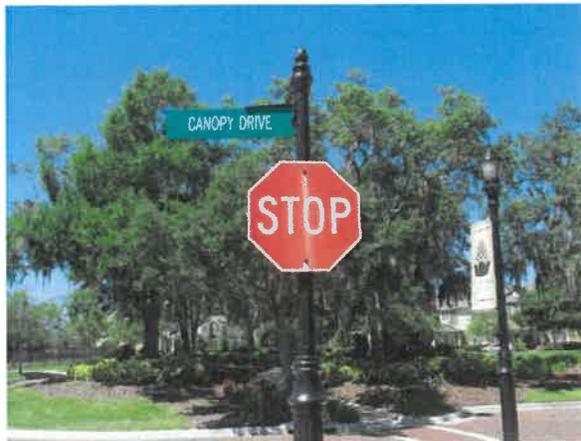
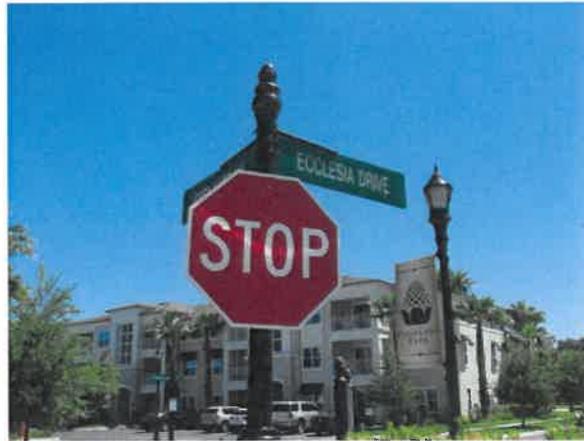
Condition: Good overall

Street and traffic sign

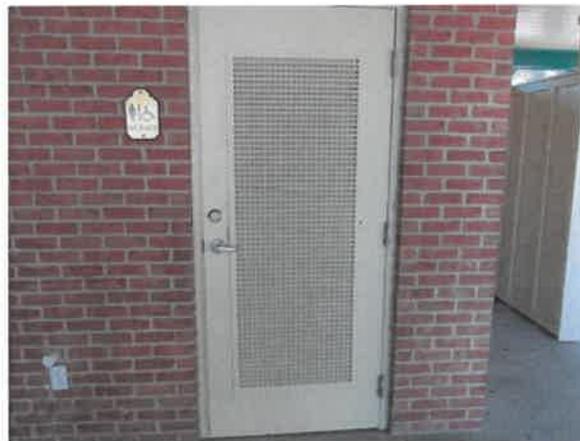
Condition: Fair overall

Door

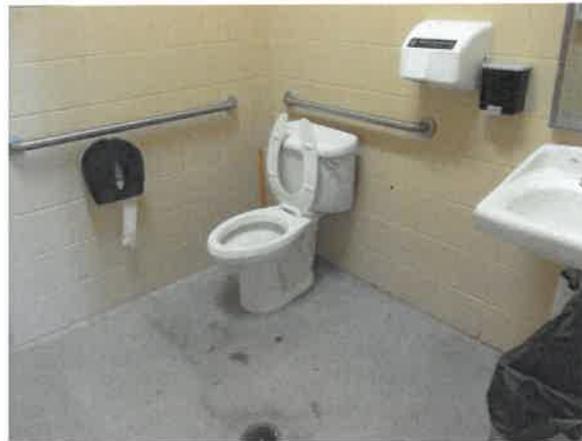
Condition: Good overall

Rest room

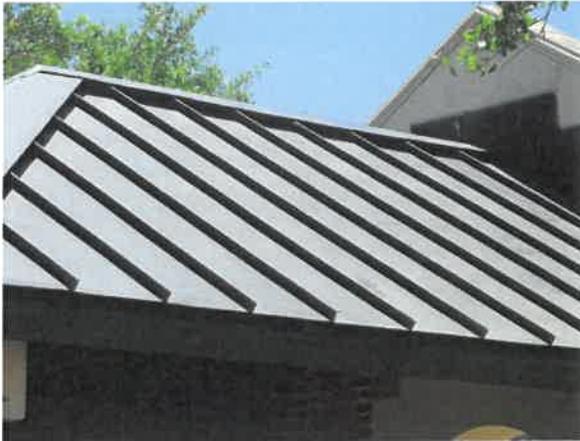
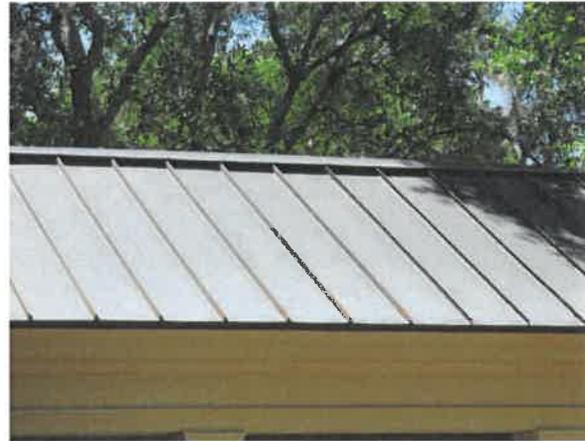
Condition: Good condition

Metal roof at bus stop

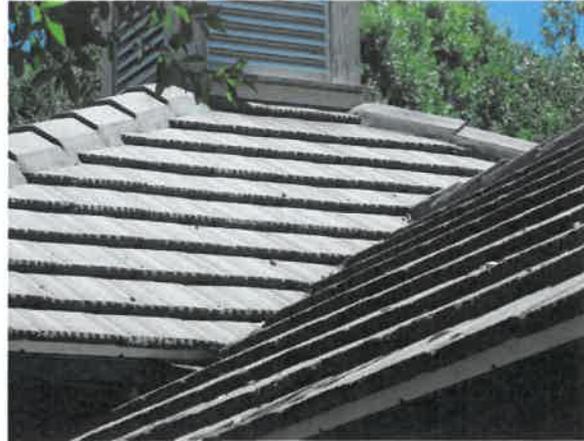
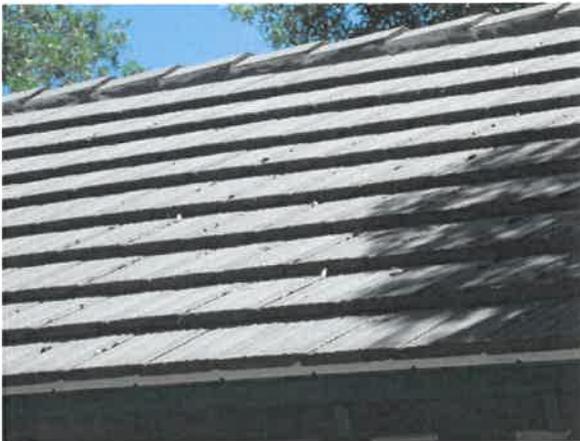
Concrete tile roof at rest room building

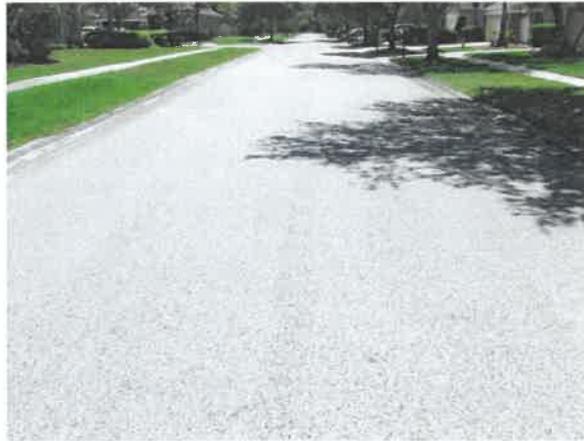
Condition: Fair overall with cracks and block cracks evident

Pavement overview

is overlaid atop the remaining base course of pavement. Total replacement includes the removal of all existing asphalt down to the base course of aggregate and native soil followed by the application of two or more new lifts of asphalt. We recommend mill and overlayment on asphalt pavement that exhibits normal deterioration and wear. We recommend total replacement of asphalt pavement that exhibits severe deterioration, inadequate drainage, pavement that has been overlaid multiple times in the past or where the configuration makes overlayment not possible. Based on the apparent visual condition and configuration of the asphalt pavement, we recommend the mill and overlay method of repaving at Windsor Place, Mandolin Reserve and Mandolin Estates.

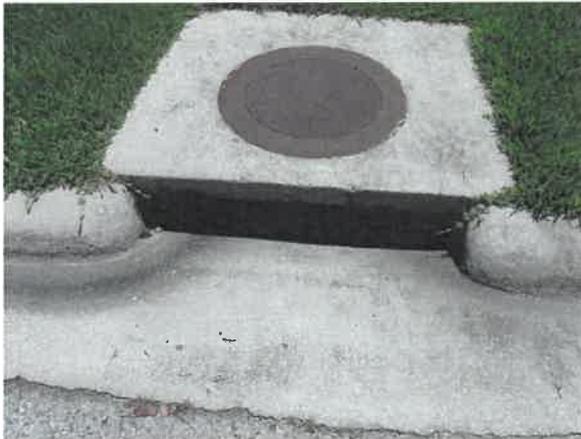
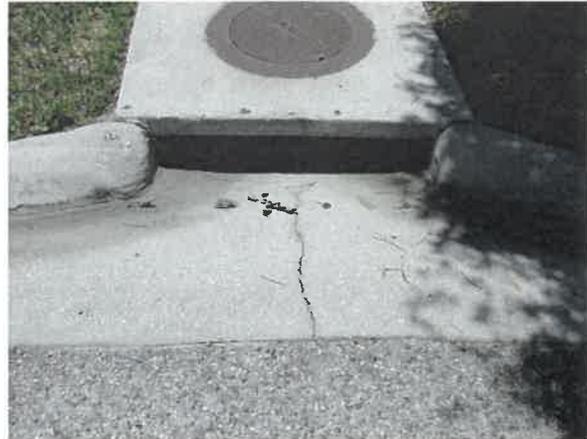
Condition: Good overall

Catch basin

Component Detail Notes: Erosion causes settlement around the collar of catch basins. Left unrepaired, the entire catch basin will shift and need replacement.

Expenditure Detail Notes: Expenditure timing and costs are depicted in the **Reserve Expenditures** table in Section 3. We recommend the District plan for inspections and capital repairs to the catch basins in conjunction with repaving.

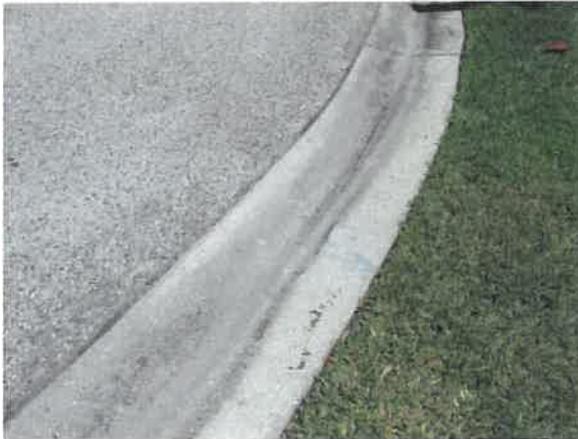
Condition: Good overall with cracks evident

Concrete gutter
